SALT SPRAY TEST

REPORT NO: TI.T.DY.006656

Test Component : Coating System Comparison. Serial Number :- Test Specification : MIL Std – 810F 509.4 Work Order : D26	Test Start Date : Refer to Tables 2 and 3. Test Duration : Four 24hr Exposure Cycles. Customer Ref. No.: - Customer : Babcock.
--	---

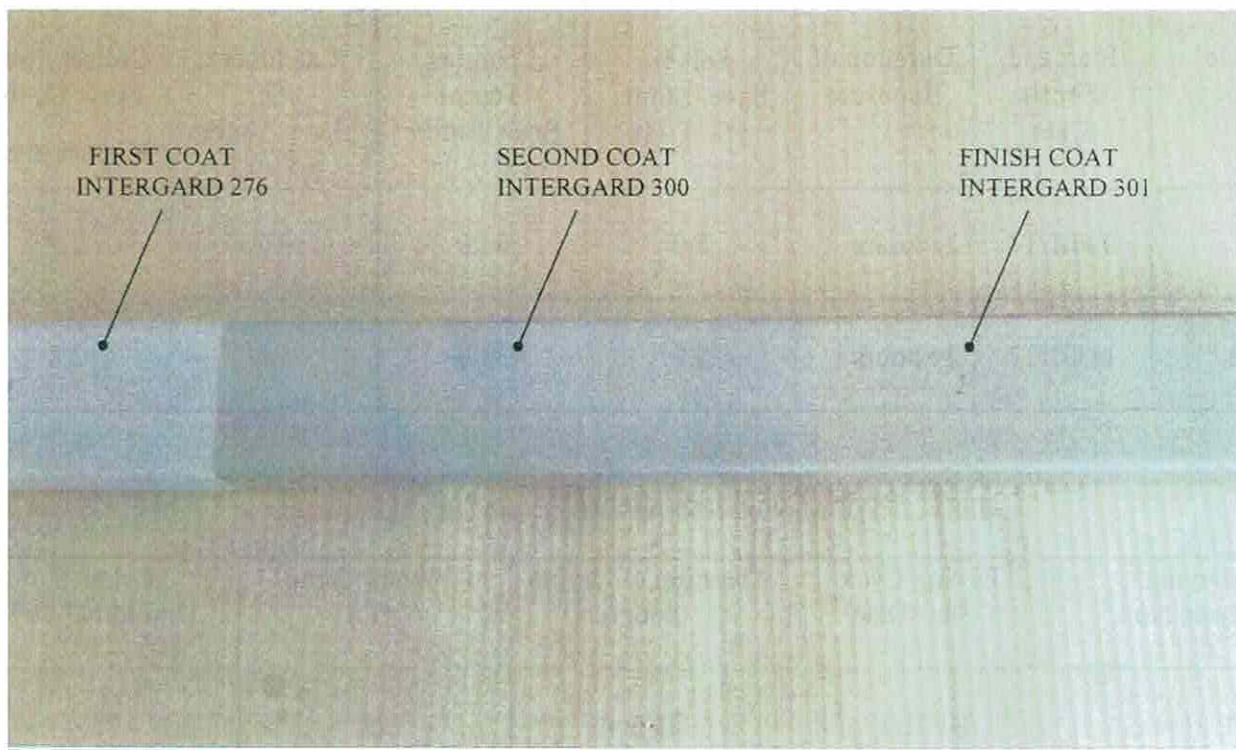
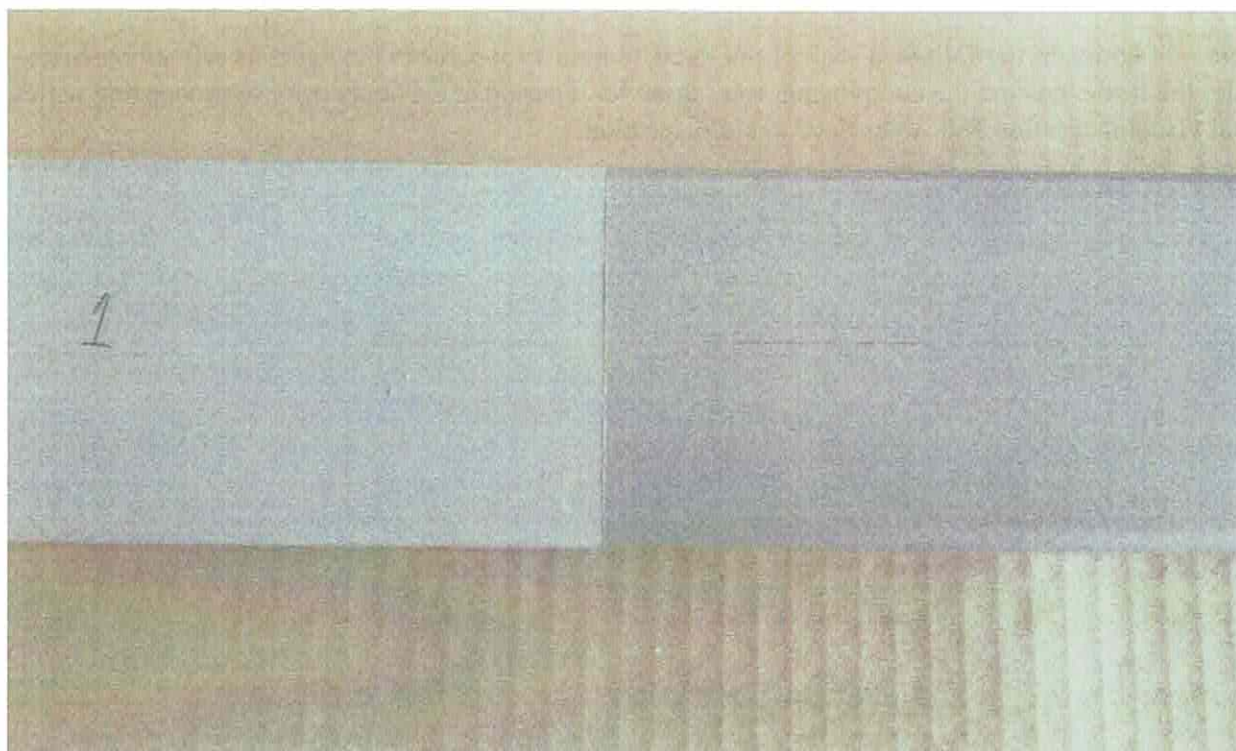
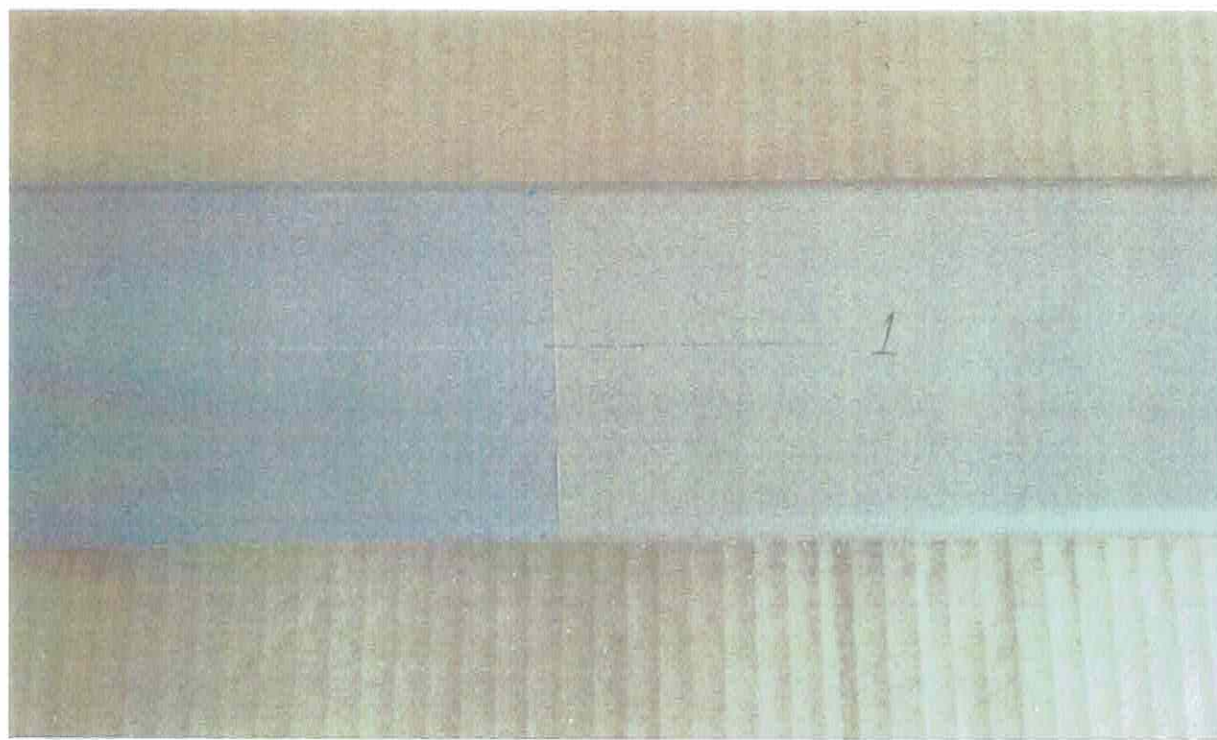
Mechanical damage was intentionally made to the three individual layers of surface coating by use of a cutting blade, so as to allow exposure of the steel substrate to the corrosive aqueous salt atmosphere.

The pre-test inspection of this sample identified no additional mechanical damage / abrasion sites on the surface of the substrate in the test areas.

Photo 1. Pre Test Condition. International Paints. Test Piece #1.

Photo 2. Pre Test Condition. International Paints. Test Piece #1.

Photo 3. Pre Test Condition. International Paints. Test Piece #1.

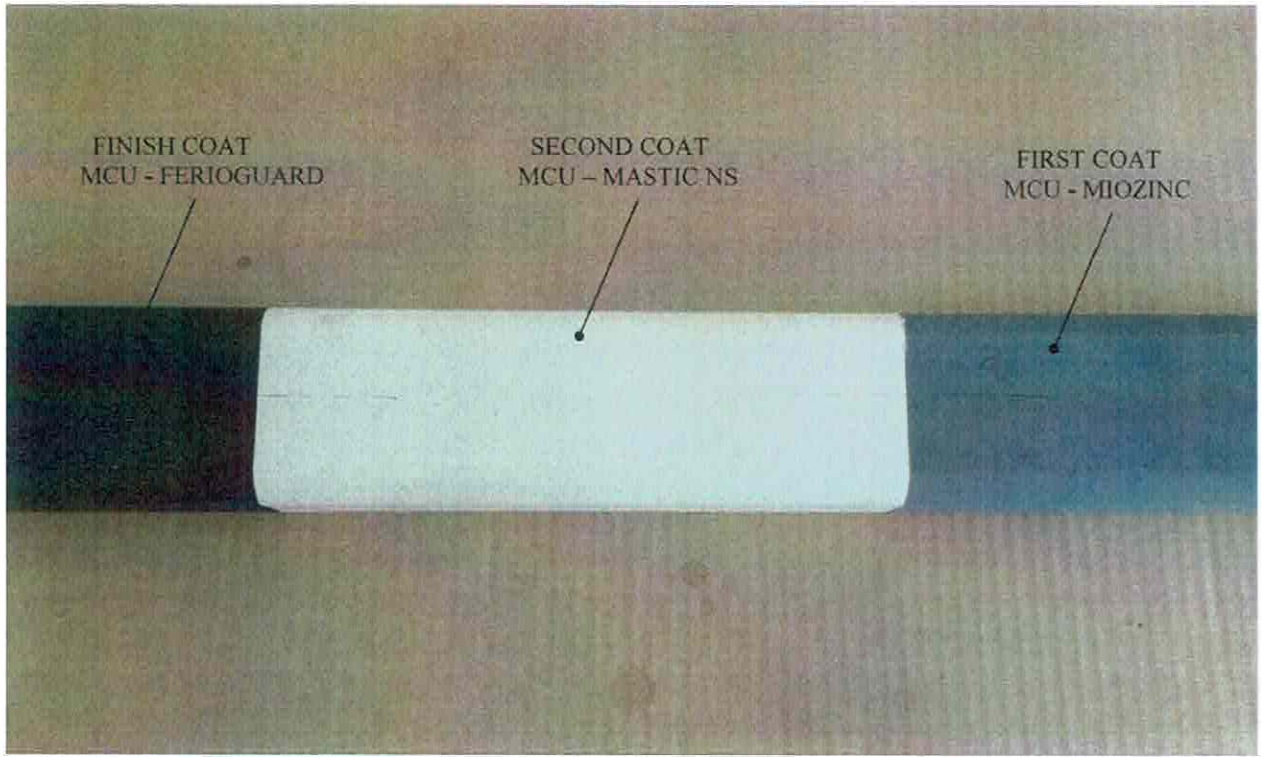
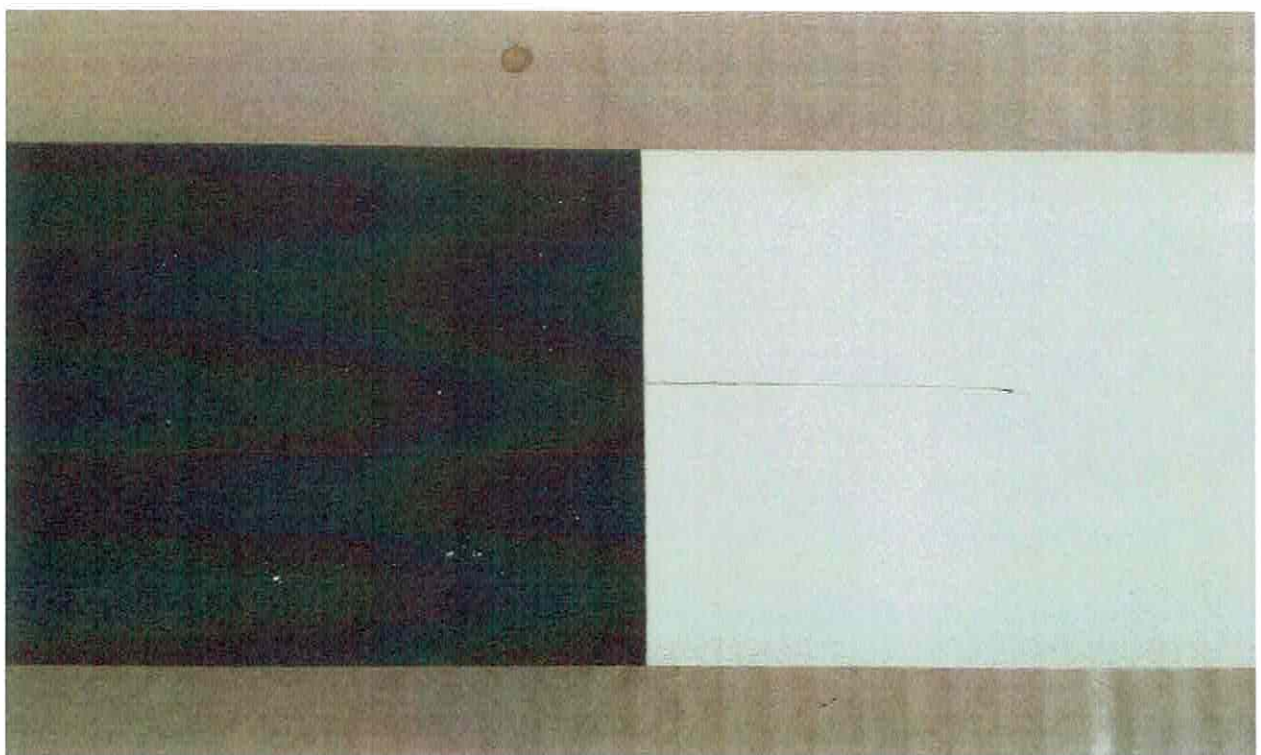
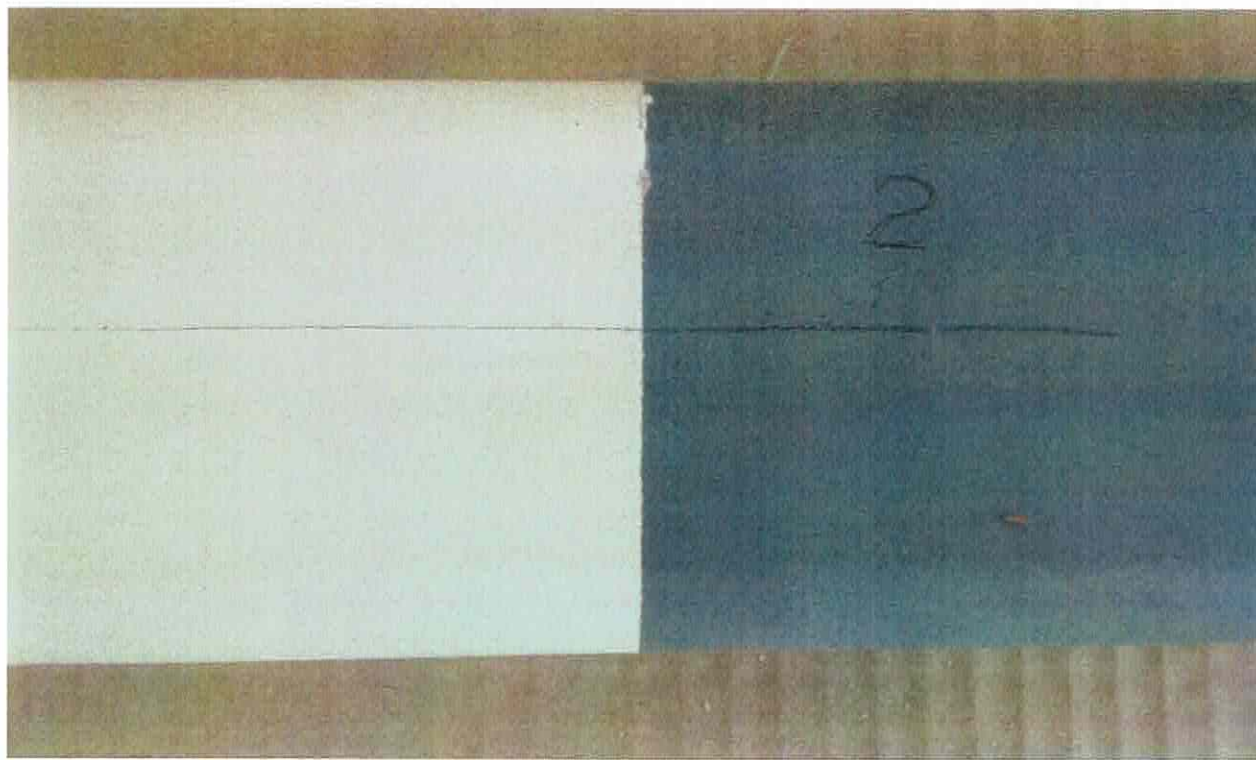
Mechanical damage was intentionally made to the three individual layers of surface coating by use of a cutting blade, so as to allow exposure of the steel substrate to the corrosive aqueous salt atmosphere.

The pre-test inspection of this sample identified no additional mechanical damage / abrasion sites on the surface of the substrate in the test areas.

Photo 4. Pre Test Condition. MCU Paints. Test Piece #2.

Photo 5. Pre Test Condition. MCU Paints. Test Piece #2.

Photo 6. Pre Test Condition. MCU Paints. Test Piece #2.

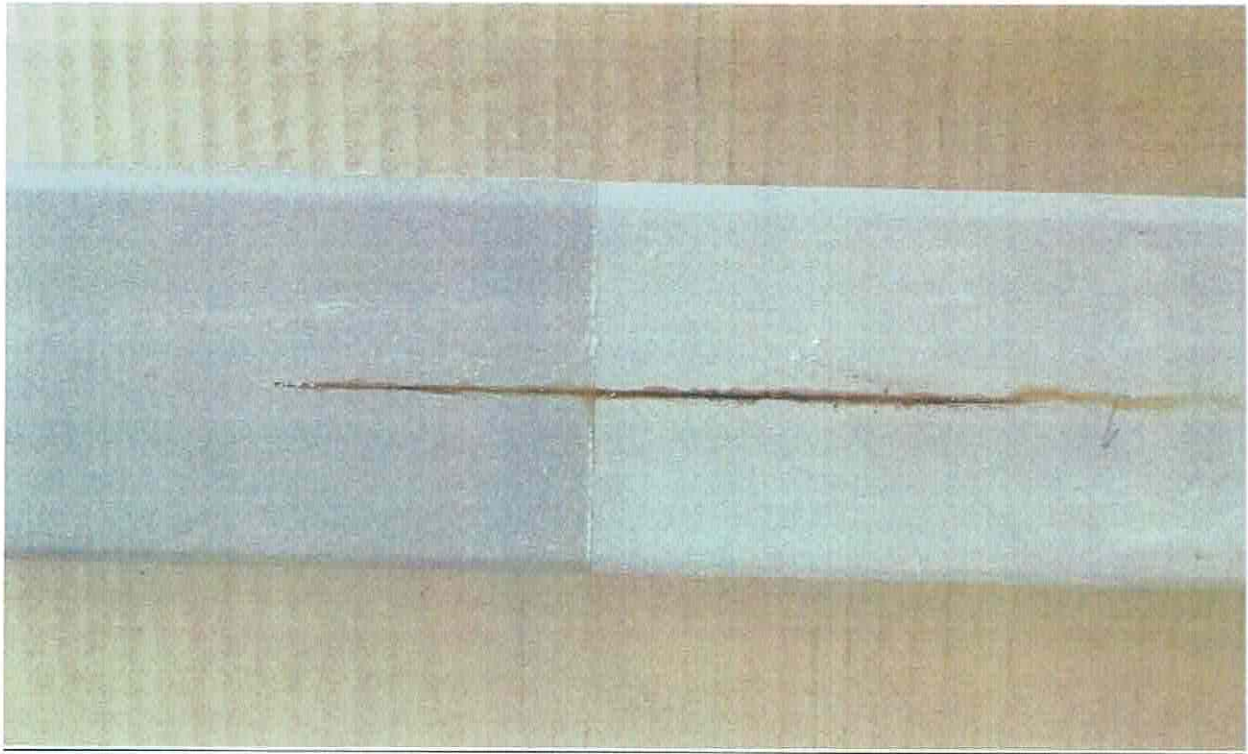
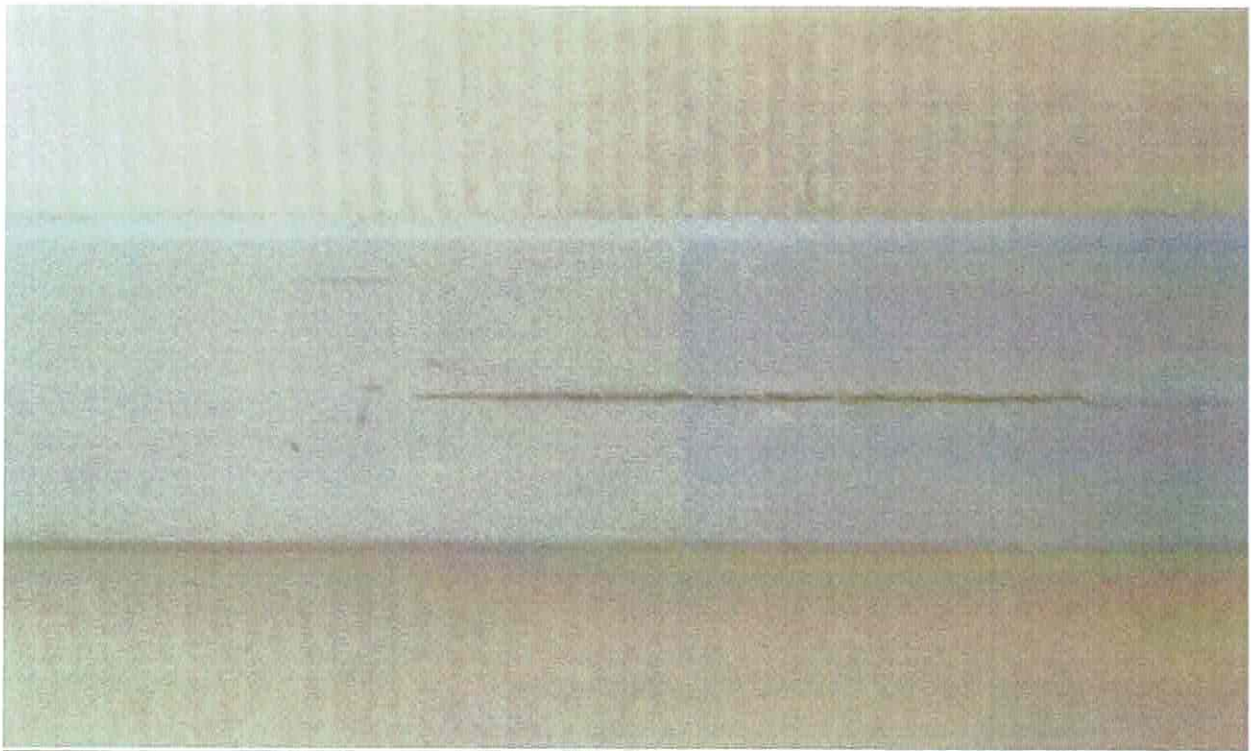
1. The intact undamaged protective coating showed no signs of breakdown. No staining was present.
2. Minor ferrous oxide staining was present along the full length of the blade cuts where the coatings had been intentionally damaged.

The intact undamaged coating showed no signs of corrosion initiating at the completion of the two exposure cycles.

Over the full length of the blade cuts, where the coatings had been intentionally damaged to expose the substrate, ferrous oxide corrosion product and staining was present.

Photo 7. Condition after Two Exposure Cycles. International Paints. Test Piece #1.

Photo 8. Condition after Two Exposure Cycles. International Paints. Test Piece #1.

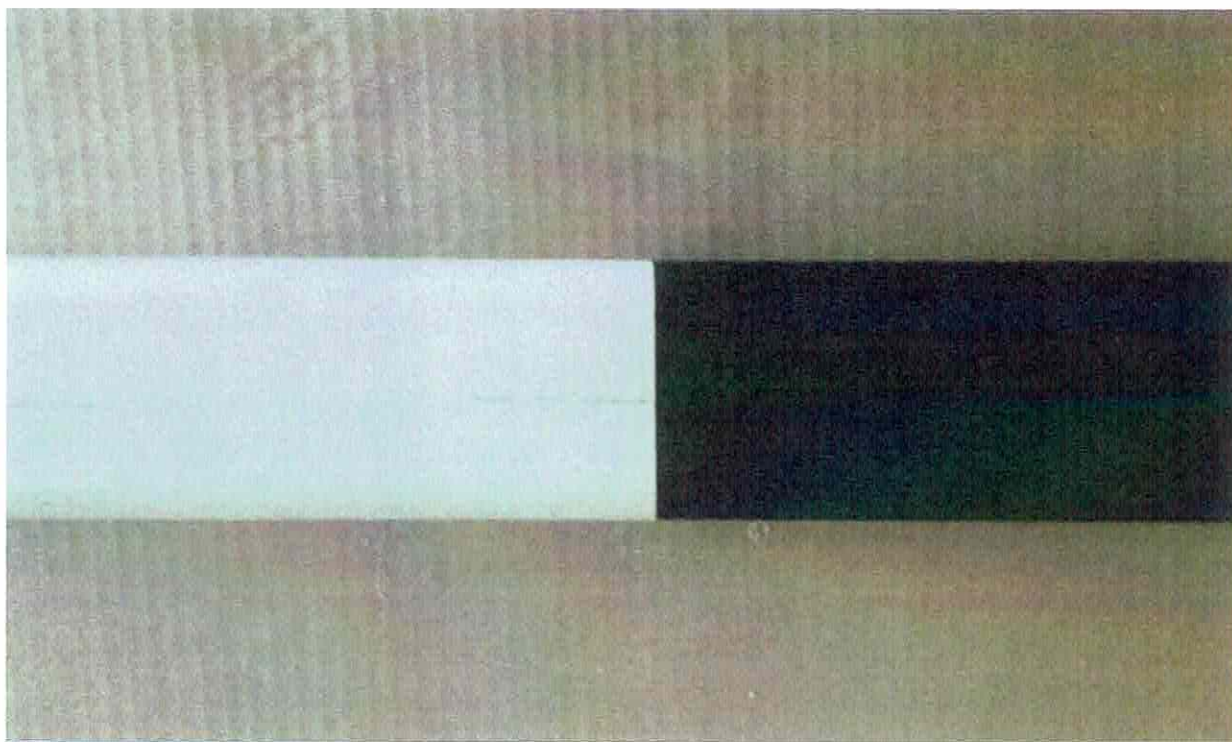
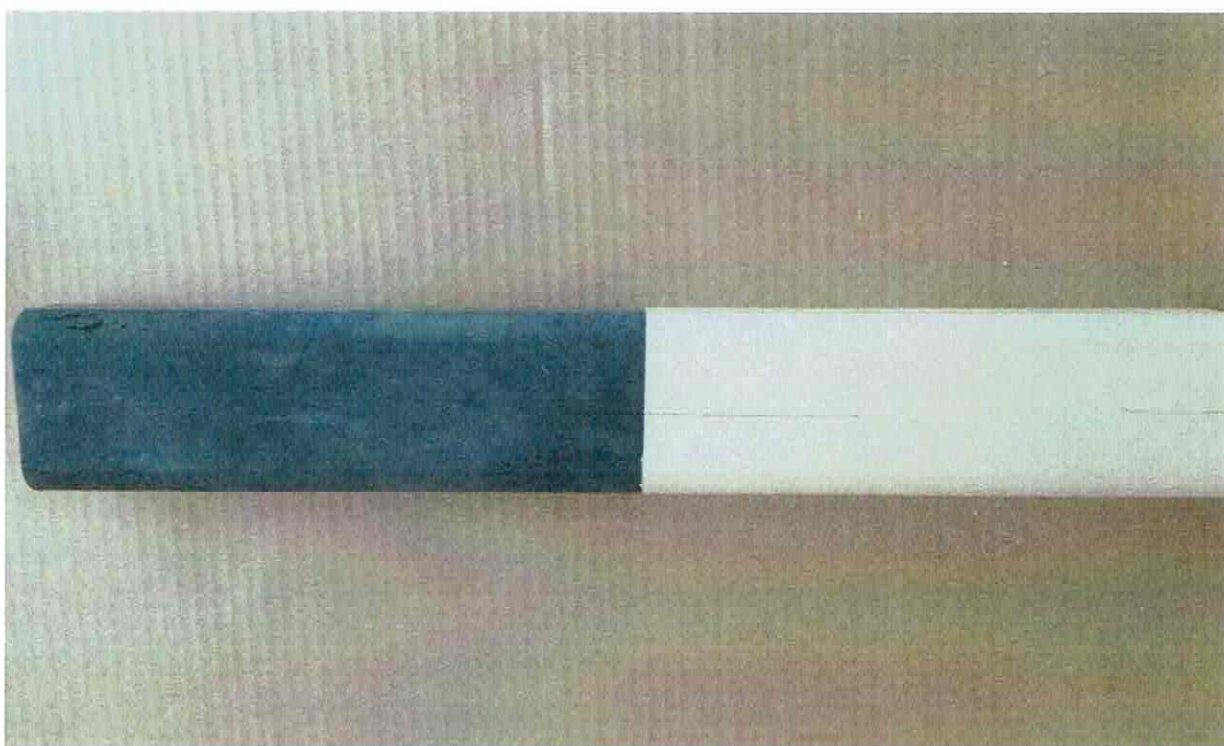
1. The intact undamaged protective coating showed no signs of breakdown. No staining was present.
2. There was no noticeable corrosion/staining present along the length of the blade cuts where the coatings had been intentionally damaged .

No corrosion sites were identified during testing of this item, either in the intact areas of coating or where the blade cuts had been made to expose the steel substrate to the corrosive aqueous salt atmosphere.

Photo 9. Condition after Two Exposure Cycles. MCU Paints. Test Piece #2.

Photo 10. Condition after Two Exposure Cycles. MCU Paints. Test Piece #2.
