**Department for materials**  
**Laboratory for Metals, Corrosion and Anti-Corrosion**  
**Protection**

## REPORT

**No. P099/14-440-2**

On the testing of anticorrosion protection  
coating "MCU-Miozinc 140  $\mu\text{m}$  + MCU-  
Topcoat 80  $\mu\text{m}$ " according to a standard EN  
ISO 12944-6:1998 for C5-I/H and C5-M/H

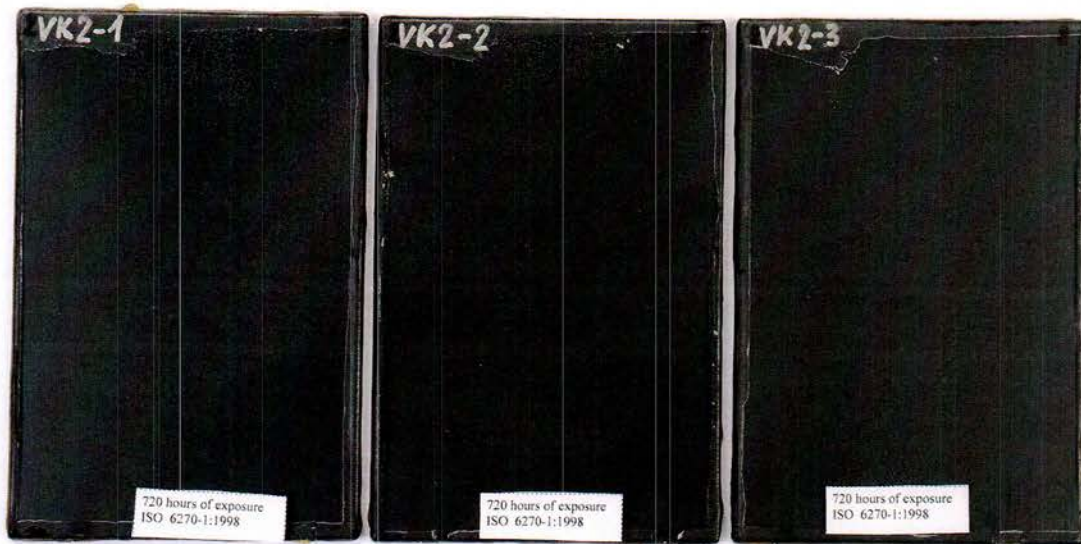
Figure No. 2 (27822d-07)

Test 2: Continuous condensation - ISO 6270-1:1998 Exposure time: 720 h	Panel			Requirements
	VK2-1	VK2-2	VK2-3	
Measured DFT [ $\mu\text{m}$ ]	228 $\pm$ 18	212 $\pm$ 22	223 $\pm$ 20	
Assessment after testing: (Picture No.2 – Annex 3)				
ISO 4628-2:03 (blistering)	0(S0)	0(S0)	0(S0)	0(S0)
ISO 4628-3:03 (rusting)	Ri 0	Ri 0	Ri 0	Ri 0
ISO 4628-4:03 (cracking)	0	0	0	0
ISO 4628-5:03 (flaking)	0	0	0	0
ISO 2409:13-1a/A.1 (class):	0	-	-	0 or 1
ISO 4624:02 [MPa]	-	6,8 $\pm$ 1,1* <sup>1</sup>	7,0 $\pm$ 1,2* <sup>1</sup>	>5Mpa or no adh. break to substrate

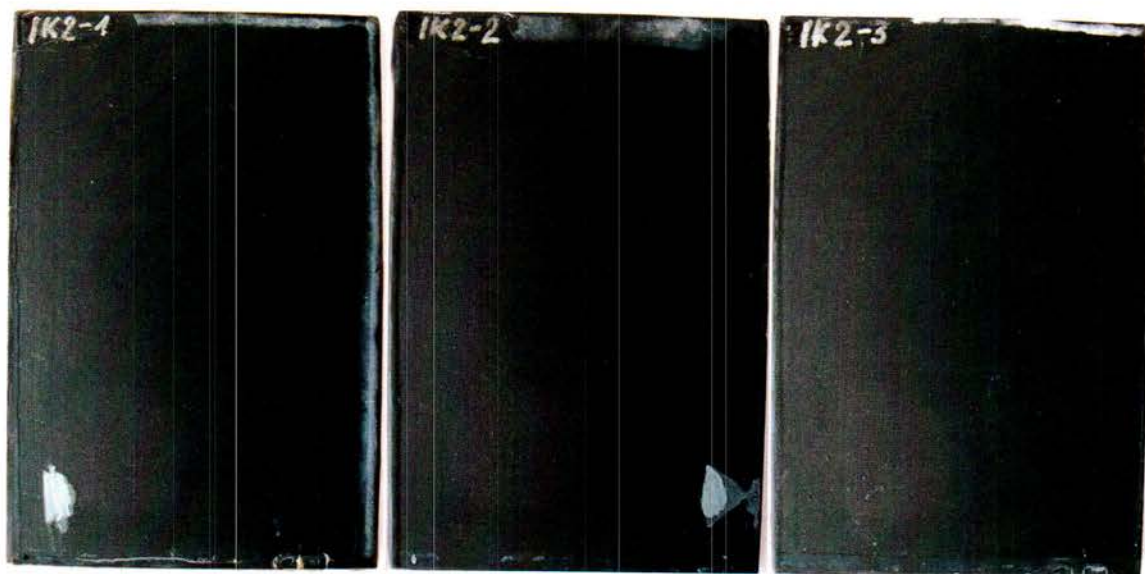
Figure No. 3 (27880d-18)

Test 3: SO <sub>2</sub> test with condensation of moisture - ISO 6270-1:1998 ISO 6988:1985 Exposure time: 30 cycles	Panel			Requirements
	IK2-1	IK2-2	IK2-3	
Measured DFT [ $\mu\text{m}$ ]	221 $\pm$ 14	216 $\pm$ 20	211 $\pm$ 8	
Assessment after testing: (Picture No.3 – Annex 3)				
ISO 4628-2:03 (blistering)	0(S0)	0(S0)	0(S0)	0(S0)
ISO 4628-3:03 (rusting)	Ri 0	Ri 0	Ri 0	Ri 0
ISO 4628-4:03 (cracking)	0	0	0	0
ISO 4628-5:03 (flaking)	0	0	0	0
ISO 2409:13 (class):	0	-	-	0 or 1
ISO 4624:02 [MPa]	-	7,2 $\pm$ 0,9* <sup>1</sup>	7,5 $\pm$ 1,1* <sup>1</sup>	>5 Mpa or no adh. break to substrate
