Case Study

IN TAIWAN

MetalTec - TC

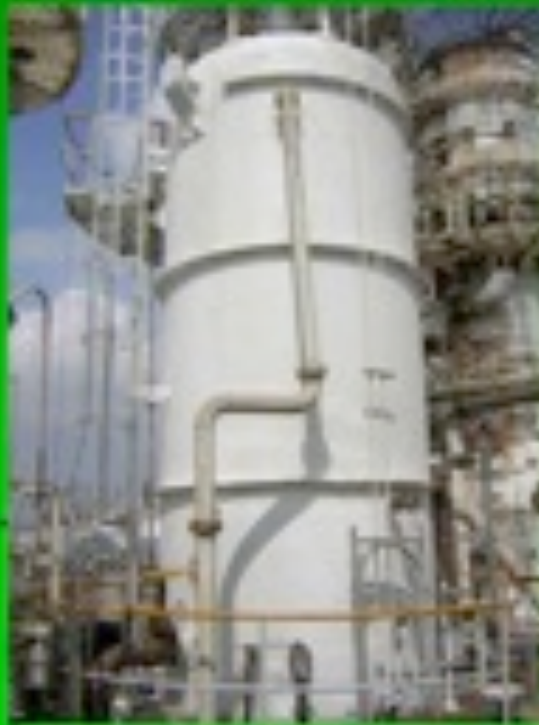
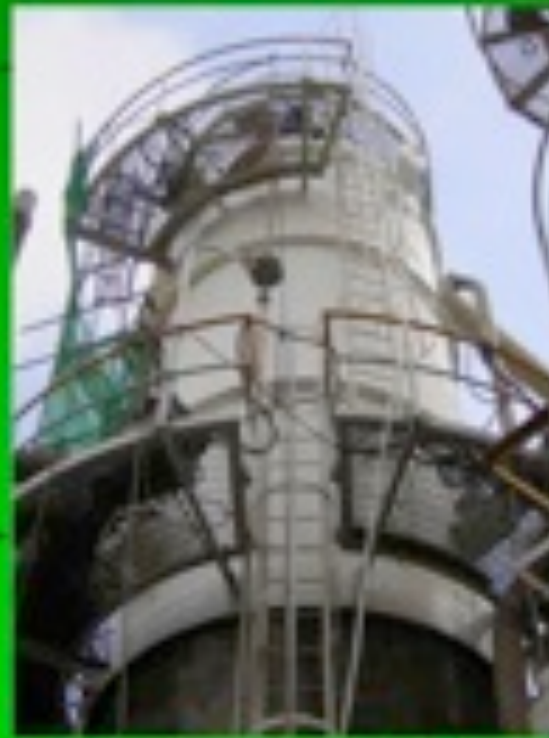
Quench tower

Bottom temp inside 158 °C → TC: 4mm
→ surface temp 68 °C

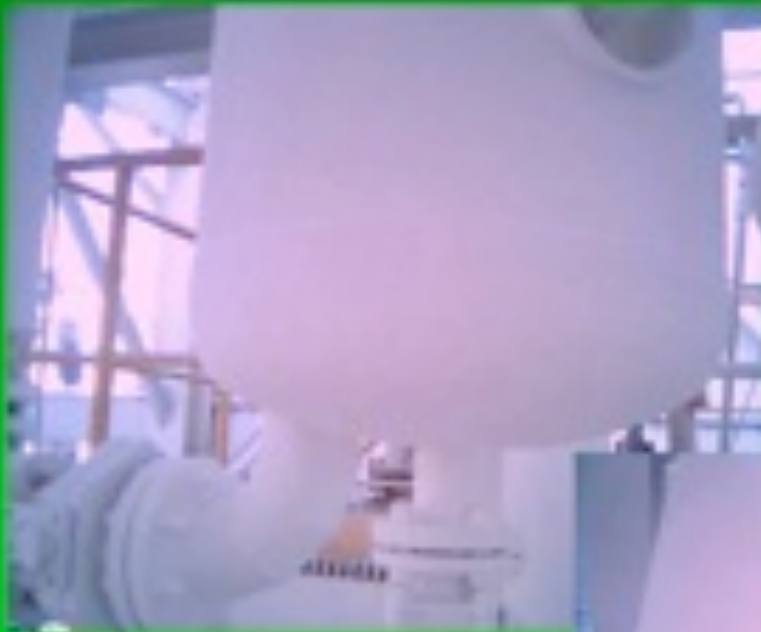
Salting out Heater

- ID:480mm
- H:1240mm
- 140 °C → 70 °C
- TC 3mm
- 2005/11/28

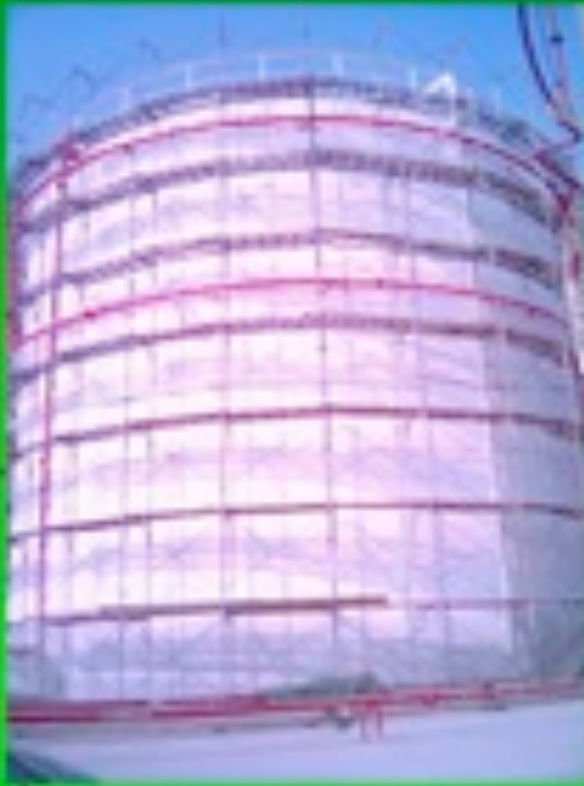
pure EDC storage tank

- D:14.5 M H :12.1M
- Tank wall: TC 1MM
- Roof: TC 1.5MM
- 70~60 °C → 約40 °C
- 2005/12/9

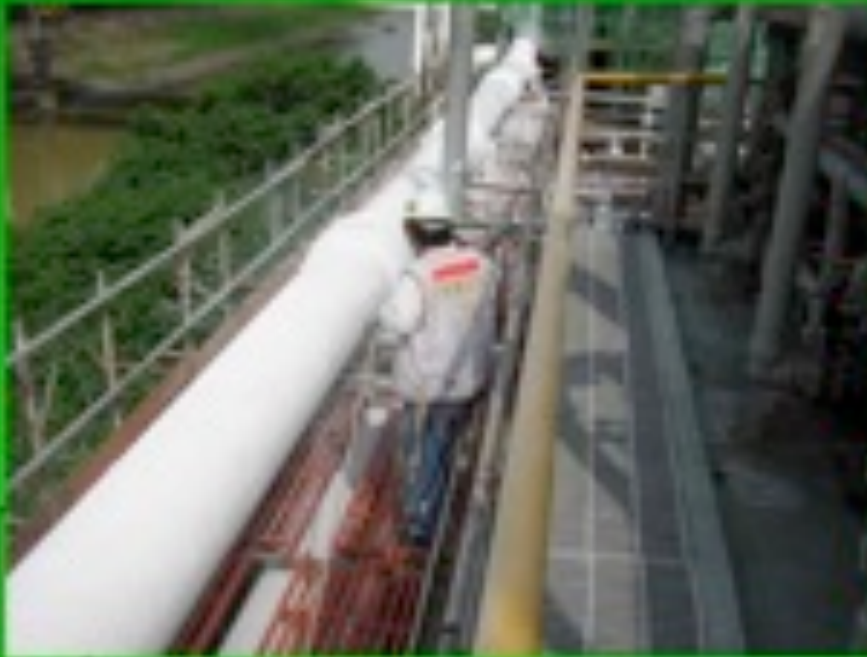
H2 pipe – prevent CUI

Material: CS
Oper temp. 15°C
In summer
temperature > dew
point, will have a lot
water. H2 is a no
odor, colorless gas
and very easy to
explode .

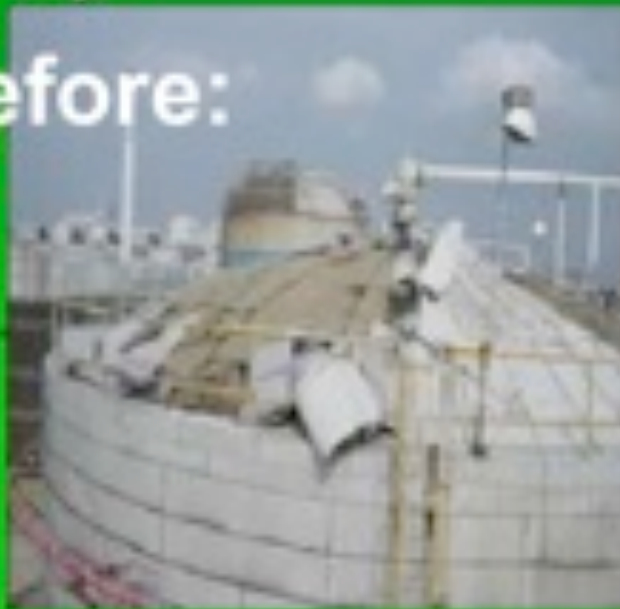
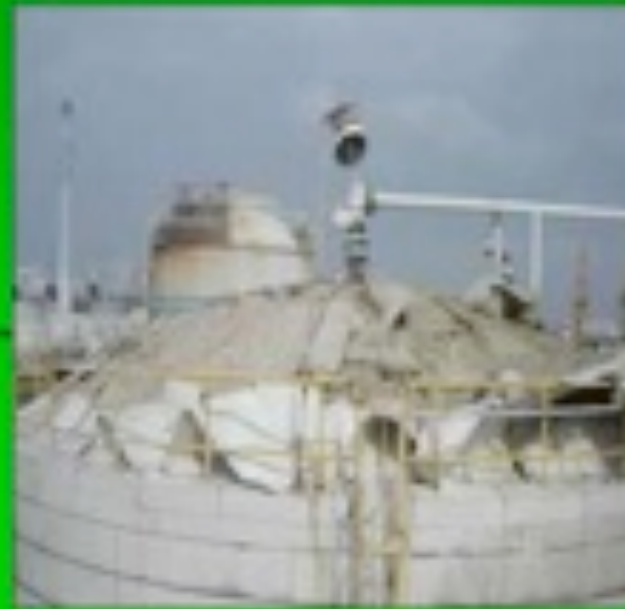
■ Before:

- AA, BA, 2EHA storage tanks. located in portside. It will polymerize when high temperature. And, will crystallize when low temperature.
- Taiwan got a lot of Typhoon. Convention insulation is easy be destroy.

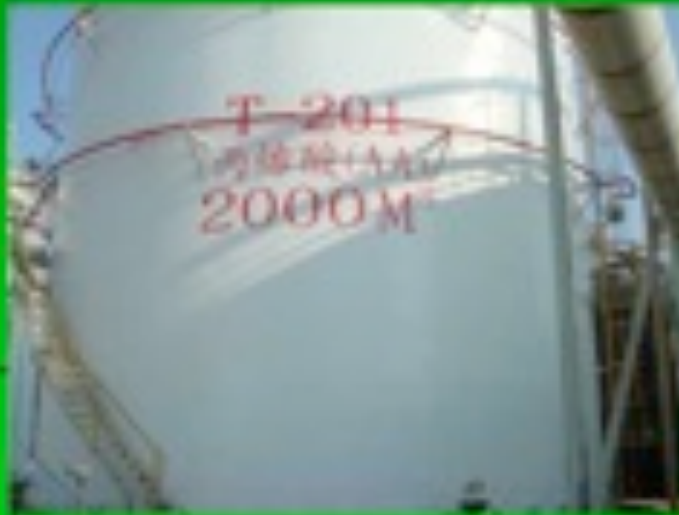
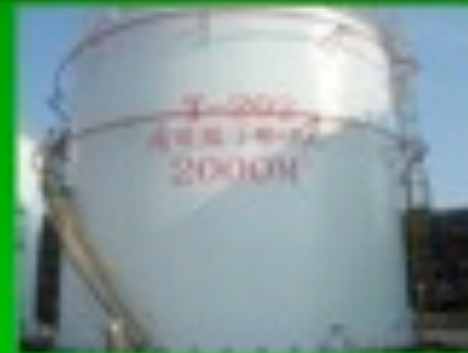
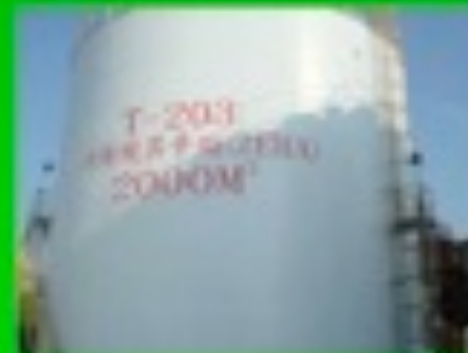
AA, BA, 2EHA After 0.75mm TC coating Dec. 2006

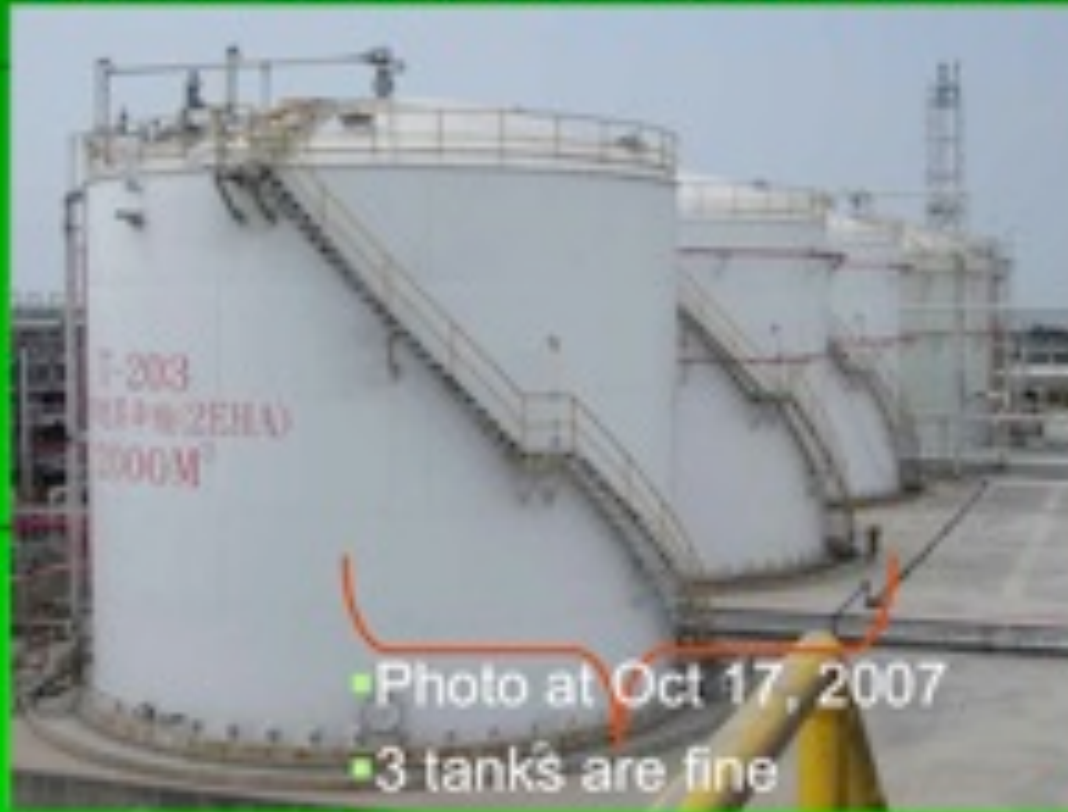
•Photo at Oct 17, 2007

After Oct 6 2007, Krosa Typhone

•3 tanks are fine

•AA, BA, 2EHA storage tanks. located in portside.

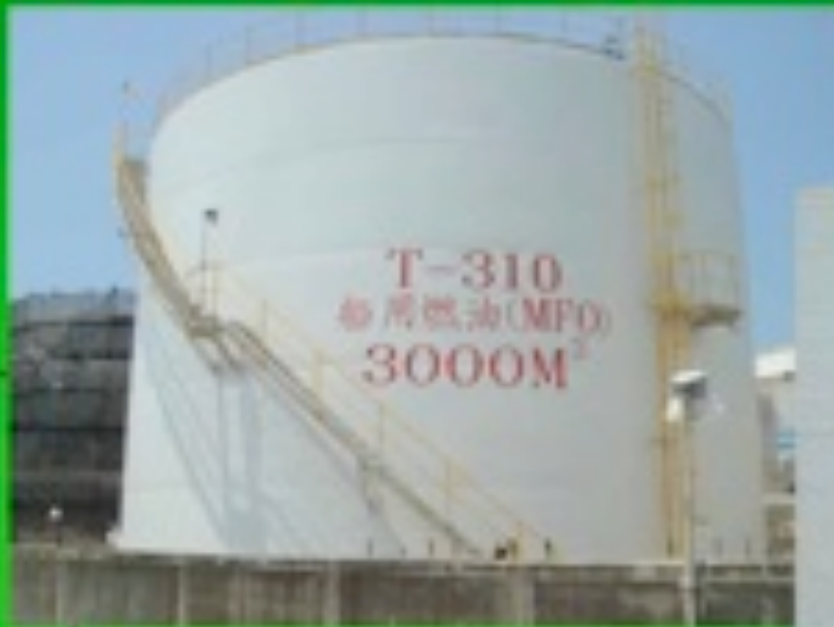
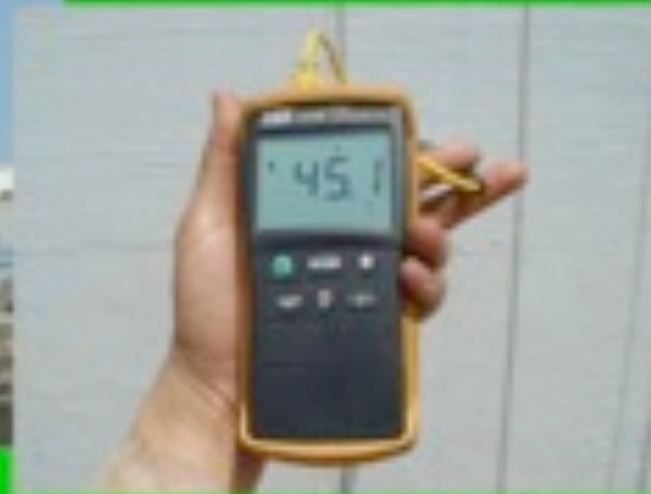
MFO tank - TC 1MM

inside 67°C, tank surface temp 45°C
