Project Experience

Desalcott– Trinidad & Tobago

MCU Coatings –
Local Desalination
Plant

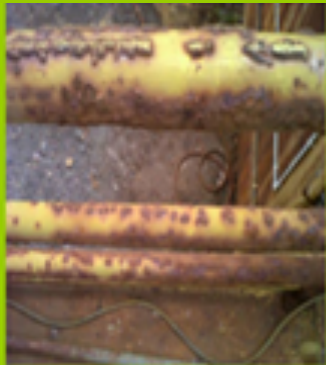
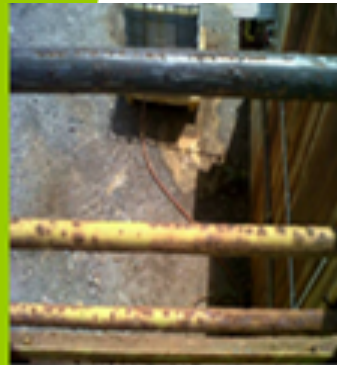
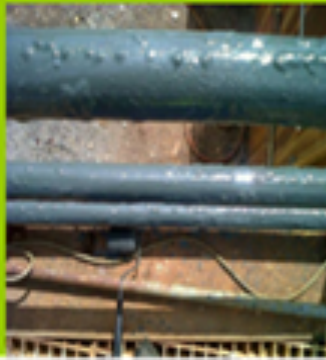
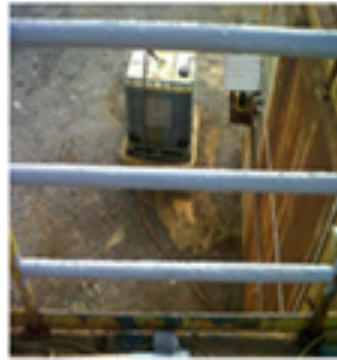
Surface Preparation – handrail #1 MBX bristle blaster, #2 sandpaper, #3 chemical wash

MCU System – Miozinc @ 5-6 mils dft & topcoat @ 2-3 mils dft

After 3 months – No loss of adhesion, corrosion, adhesion or colour failures.
Handrail used to be recoated every months using traditional epoxy coating system.

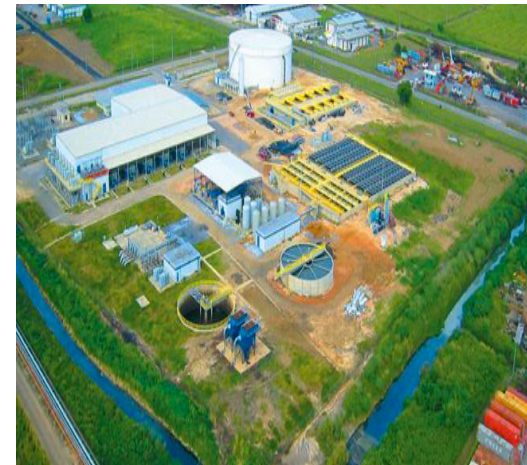
Area – Extreme Salt
Water Environment,
Sodium Hypochlorite
(chlorine bleach), Raw
Salts etc
