Project Experience INFRASTRUCTURE

St Lucia Government – St Lucia

Supply of MCU Coatings for demo on stadium beam structure in February 2016.

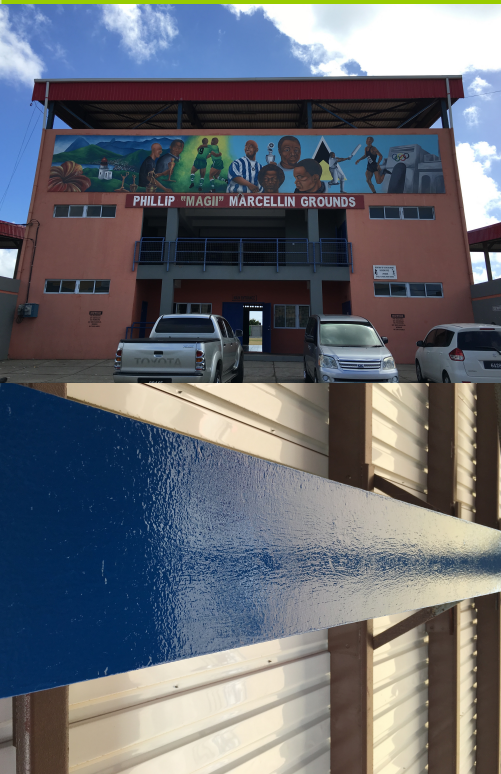
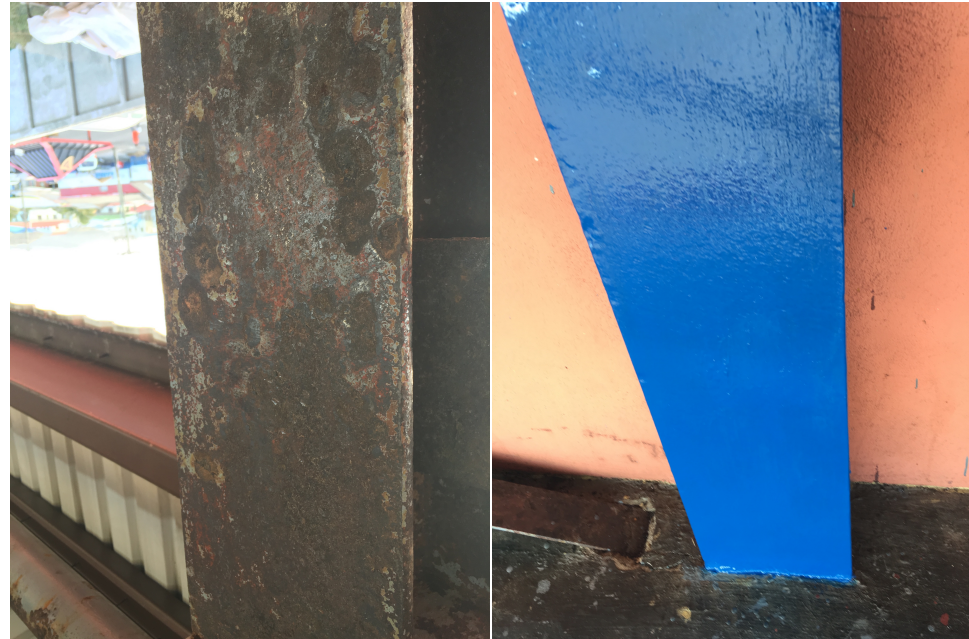
Presently, MCU Coatings is in perfect condition without any failures as traditional coatings fail within months of application.

Surface Preparation – Power tool & Solvent wipe

MCU system – Miozinc @ 4-5 mils dft & topcoat @ 2-3 mils dft
